Prepared by: EOR for the City of Fitchburg  
EOR Project #01052-0009

Final Report – submitted November 2021.

## Cheryl Drive Flooding Analysis

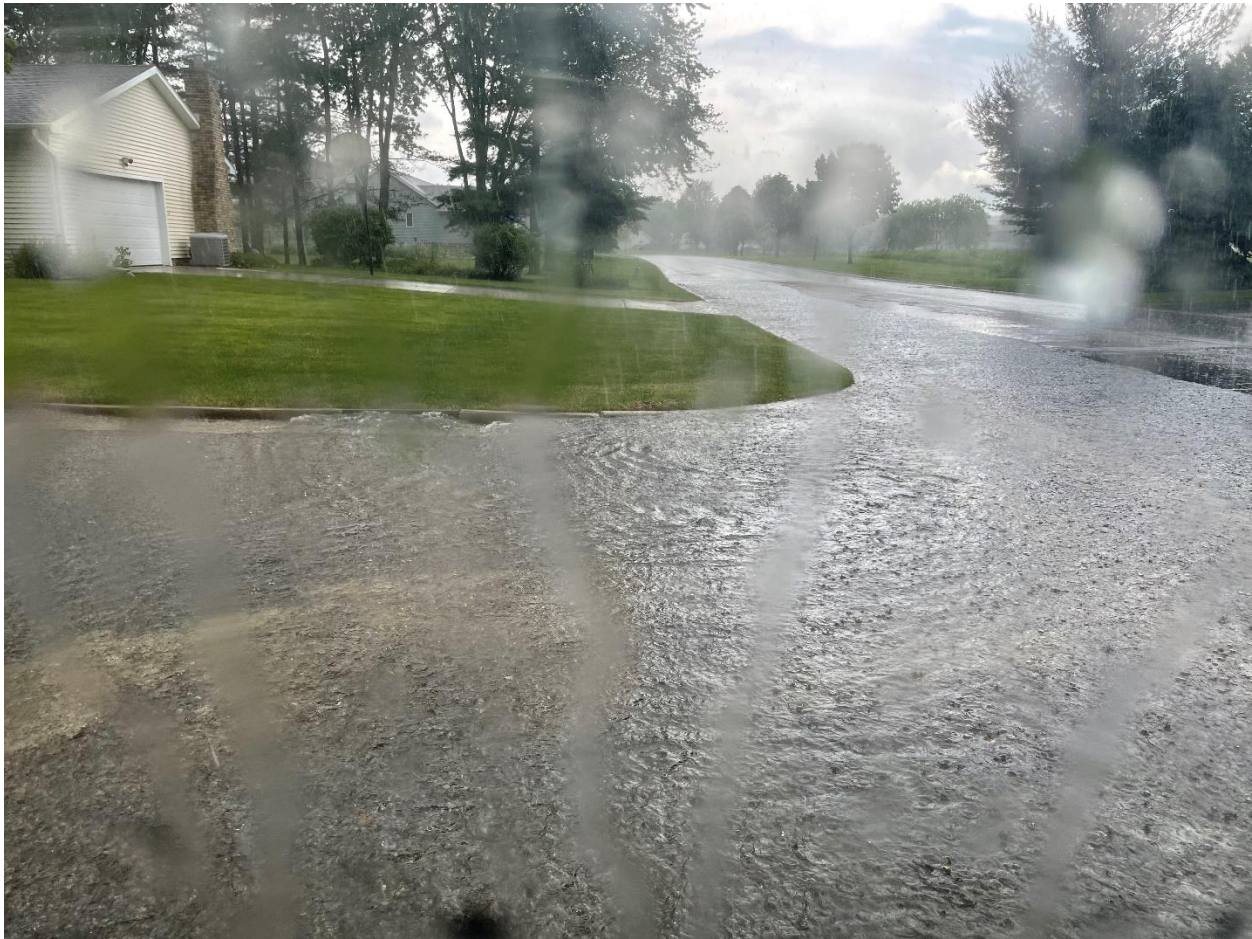
### Cover Images

Street flooding on Cheryl Drive, June 7, 2021 (~1.25" rainfall over two hours). Looking west from the Jacquelyn Drive intersection.

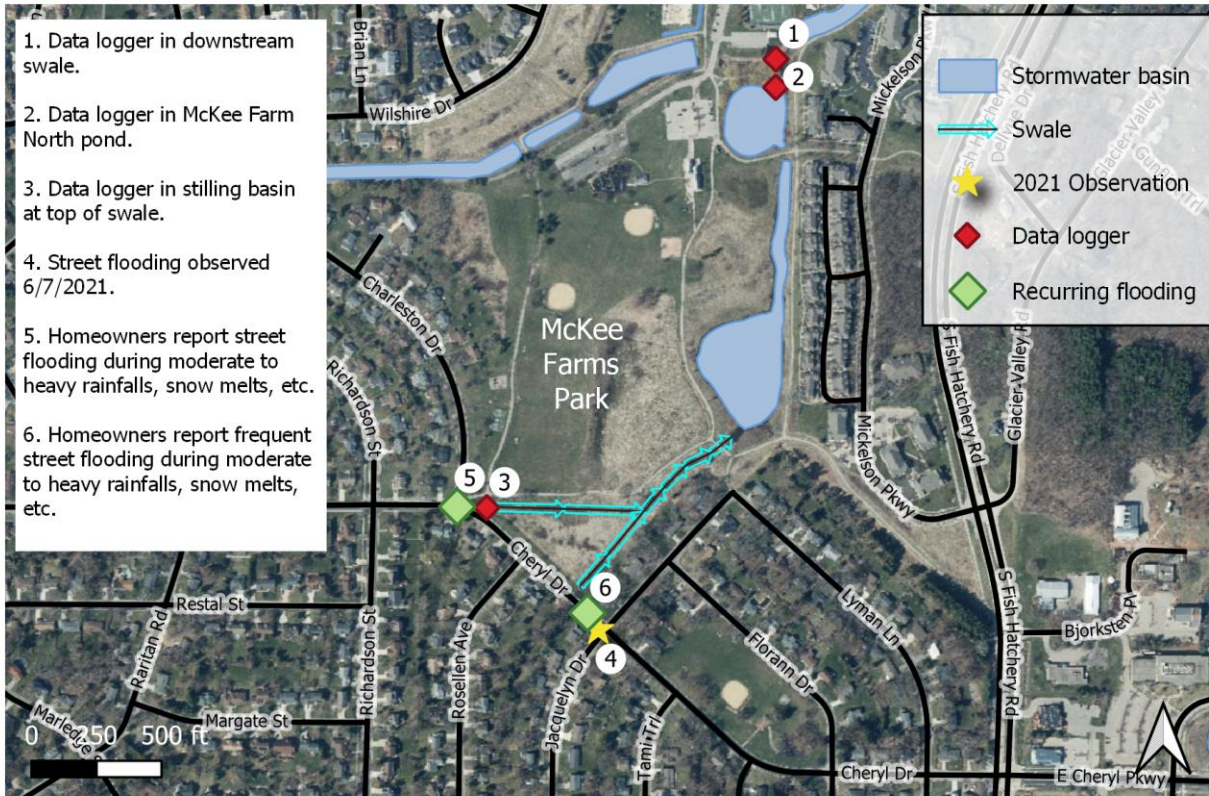
**Figure 2. Field data collection and Cheryl Drive street flooding reports / observations.**

- Observations and photos during 1.25" of rainfall in two hours on June 6<sup>th</sup>, 2021. This storm, which was highly localized over the City and Tower Hill neighborhood, resulted in street flooding at the intersection of Cheryl Drive and Jacquelyn Drive including stormwater surcharging from the inlets at the southwest corner of that intersection. The McKee Farms swales and culverts were nearly full during this event, but there was no street flooding observed at the intersection of Cheryl Drive and Charleston Drive. Unfortunately, there were no additional intense rainfall events directly observed by City staff during the project, as summer 2021 was dry and intense rainfalls tended to occur only at night and/or on weekends.

- Photographs and a video provided by a resident during 0.75" of rainfall over 45 minutes on Saturday, August 7, 2021. The video and photographs showed street flooding at the intersection of Cheryl Drive and Charleston Drive. It should be noted that there was a significant storm the night prior (1.3"), so it is likely that the upstream watershed was saturated and unable to absorb water at the time of this event.

distributed to nearby homeowners prior to the first public information meeting. These various data suggested that the Cheryl Drive – Charleston Drive intersection was frequently flooded (five or more time per year) including over-the-curb intersection flooding and hazardous driving lane conditions shown in photographs from 7/21/2016, when approximately 2.8" of rain fell over two hours at the nearest hourly precipitation gage (MSN airport). Homeowners also identified the section of Cheryl Drive to the east near Jacquelyn Drive as having frequent street flooding.

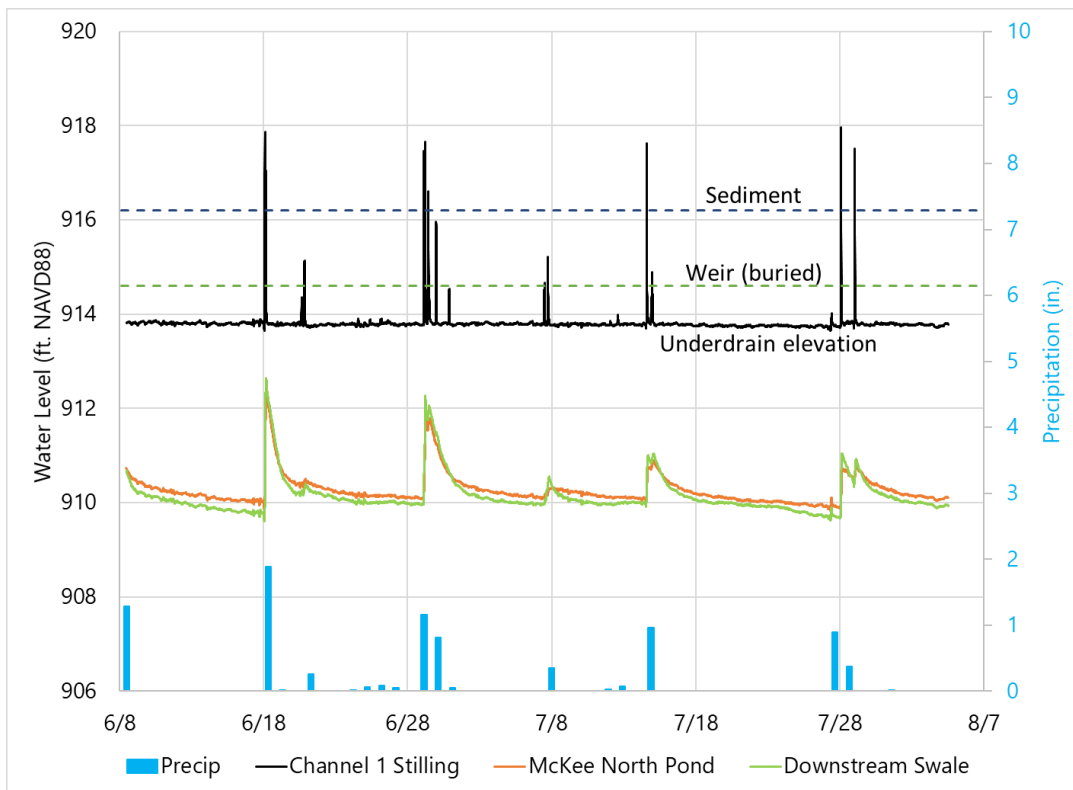
**Figure 3. Water level and rainfall data.**

- The monitoring period was relatively dry compared to a typical summer, with only 4 events over 0.8" and one over 1" (1.89" on 6/18).
  - Water levels in the ponds only rose more than one ft on two occasions and water levels receded fairly quickly (within a few days).

- The stilling basins for Channels 1 and 2 each consist of a storm sewer pipe outfall, an 18" underdrain pipe that carries low flows underground towards the South Pond, and a higher concrete weir section that forms the start of the swale that carries higher flows downstream. For most of the period, water levels were even with the invert of the underdrain. On five separate occasions, the water levels in the Channel 1 stilling basin rose higher than the sediment deposited over the buried weir and flowed down the channel. As shown in **Figure 2**, if the weir and upstream end of the channel was not buried with sediment, water levels in the stilling basin likely would not have reached these levels. The upstream (storm sewer) implications of this are explored in later report sections.

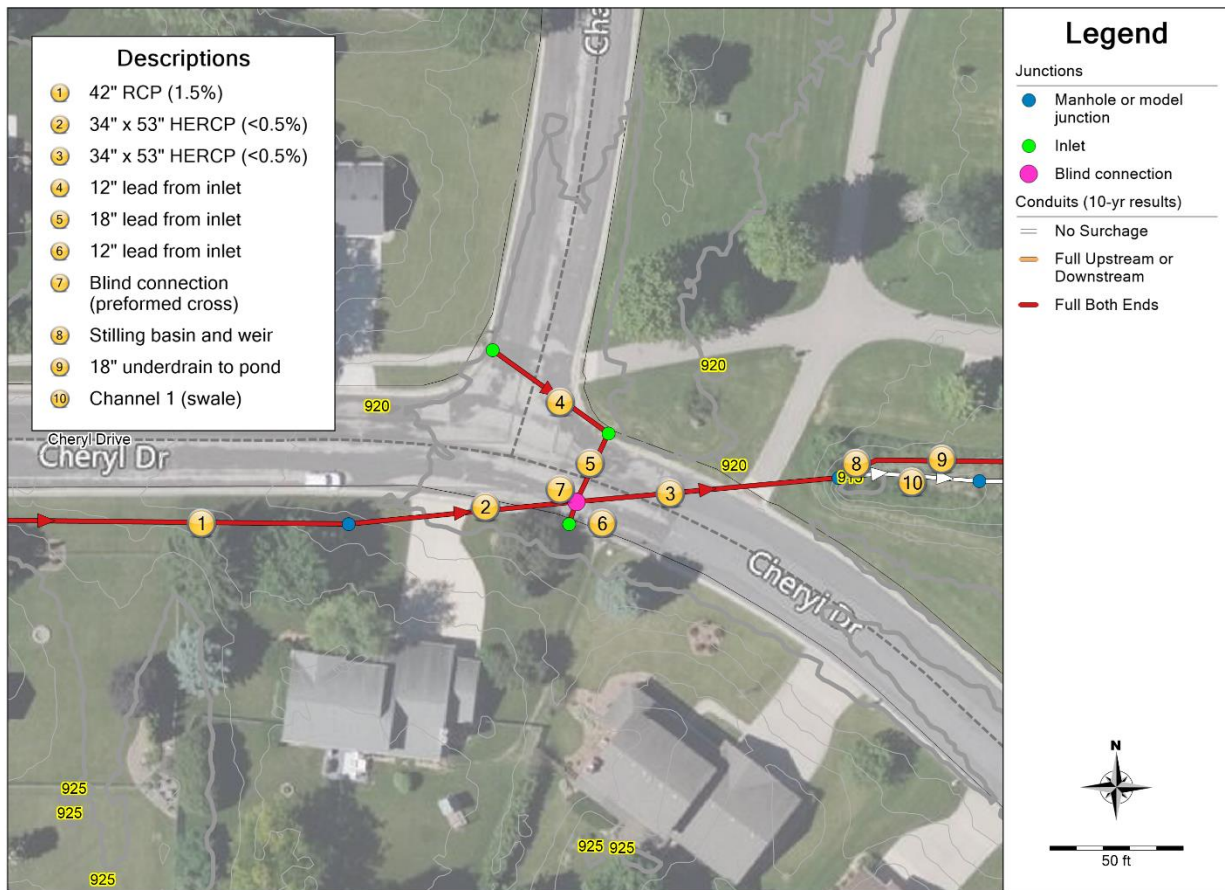
**Figure 5. Storm sewer and start of Channel 1 near Cheryl-Charleston intersection.**

There is also a “blind connection” (no manhole) along the elliptical pipe in the intersection where pipes from the three intersection inlets connect to the elliptical pipe at 90 degree angles. This connection is described in the original plans as a “preformed cross”, which appears to be failing (slipped joints) when viewed from the available vantage point from the southern intersection inlet. This slipped connection is likely limiting drainage from the intersection and could possibly create sinkhole conditions due to excessive leakage.

2. Cheryl-Charleston intersection.	<p>Pipe surcharge: <b>&lt; 2-yr</b></p> <p>HGL below rim for 10-yr: <b>NO</b></p> <p>Flooding limited to ROW for 100-yr: <b>NO</b></p> <p>Structures Impacted for 100-year: <b>NO</b></p>	<ul style="list-style-type: none"> <li>• The storm sewer here is severely limited by capacity, particularly the low-slope (&lt;0.5%) elliptical 34" x 53" pipes</li> <li>• The lack of pipe capacity is magnified by the downstream conditions at the upstream end of Channel 1 (sediment blockage)</li> <li>• Street flooding here appears to be primarily caused by the surcharged conditions in the main storm sewer system, not inlet capacity. Nevertheless, doubling or over-sizing inlet grates and upsizing catch basin lead sizes would help address street flooding once other system changes are made.</li> <li>• The failing "preformed cross" connection between the inlet leads and the elliptical pipe is not explicitly modeled but is likely further restricting flows. The connection should be replaced with a structure that allows maintenance access.</li> <li>• Running the north side inlets directly to the stilling basin of Channel 1 should be considered during repair to limit junction energy losses and simply the structure.</li> <li>• Due to topography and the large watershed draining here, even with significant upsizing and downstream improvements it will likely be difficult to bring the storm sewer to new design standards (10-yr)</li> <li>• The HGL is above the rims of any structures at the 2-yr storm and larger, and street flooding extends beyond the ROW for 5-</li> </ul>

- The two elliptical pipes near the intersection of Cheryl Drive and Charleston Drive are very flat and appear undersized, especially the downstream section of pipe that outlets to Channel 1. The upstream end of that pipe has a failing connection to two inlet leads at a pre-formed cross, with no manhole for access or inspection. Upsizing that pipe has considerable benefits in that area and uphill to the next intersection.

- **Storm sewer video inspection estimated cost: \$7,500**
2. **Near-term (2-3 years):**
- Replace the failing pre-formed cross at the Cheryl-Charleston junction (Alt. 3) and replace the HERCP with a 3' x 7' box culvert, along with other minor changes. Estimated cost: \$137,900

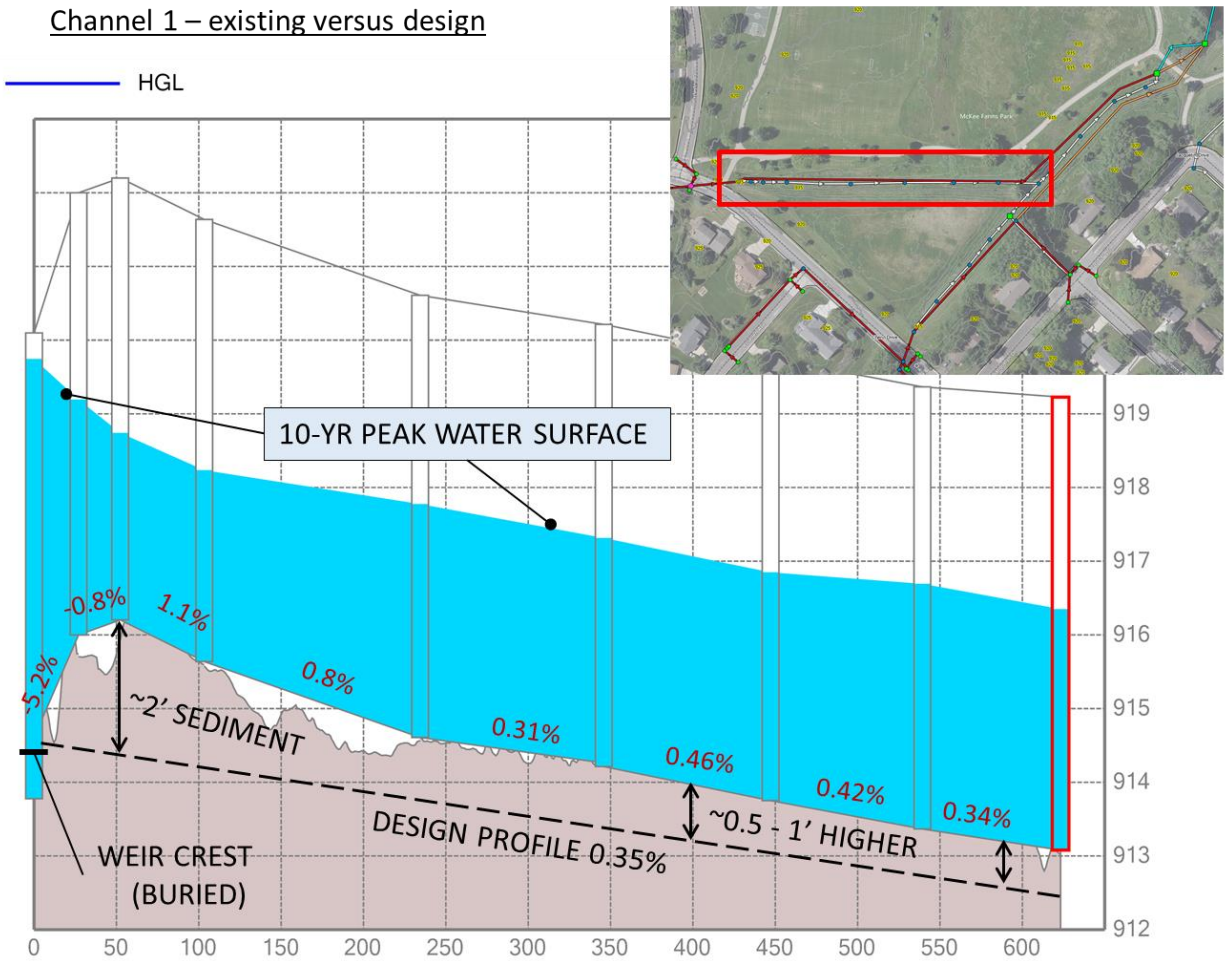
**Figure 6. Existing Channel 1 swale profile compared to design.**

3. “Channel 1” (western swale). The original McKee Farms Park drainage plan identifies the western swale as “Channel No. 1,” now referred to as Pembroke Greenway. This channel starts at a very shallow stilling basin at the outfall of the elliptical pipe coming from the Cheryl-Charleston

intersection. There is an 18" underdrain pipe that captures lower flows from the stilling basin and daylights just upstream of the six culverts that drain the swales into the McKee Farms Park South Pond. When the water level in the stilling basin is higher, such as during runoff events, the water enters Channel 1 by flowing over a concrete trapezoidal weir that was designed to be 4" higher than the invert of the underdrain. However, the weir has a significant amount of sediment and what appears to be fine-grained asphalt or chip-sealing debris. This mound of sediment continues downstream approximately 100 ft, with a maximum elevation approximately 2.0 ft higher than the designed elevation of Channel 1. This sediment is also heavily vegetated with thistles and nettles which are likely to inhibit water flow. The deposited sediment and vegetation thins out downstream of the mound at the upper end, but the channel is still generally 0.5 – 1.0 ft higher than designed throughout its length. The sediment deposit just downstream of the weir, as well as a comparison of the current channel profile and slopes to the designed slope (0.35%) and profile, is shown on Figure 6.

- It is recommended that this work be accompanied by a long-term inspection, maintenance dredging, and more aggressive vegetation management plan to prevent these conditions from developing in the future. Model testing indicates that the storm sewer HGL at the Cheryl-Charleston intersection rises by 0.2 ft when there is 0.5 ft of sediment built up in the upper section of Channel 1, and by 0.5 ft when sediment has built up to 1 ft of depth, Therefore, it is recommended that maintenance dredging be scheduled when there is 0.5 ft (6 inches) of sediment built up in the upper section of Channel 1, and be completed before there is 0.75 ft (9 inches) of build-up.

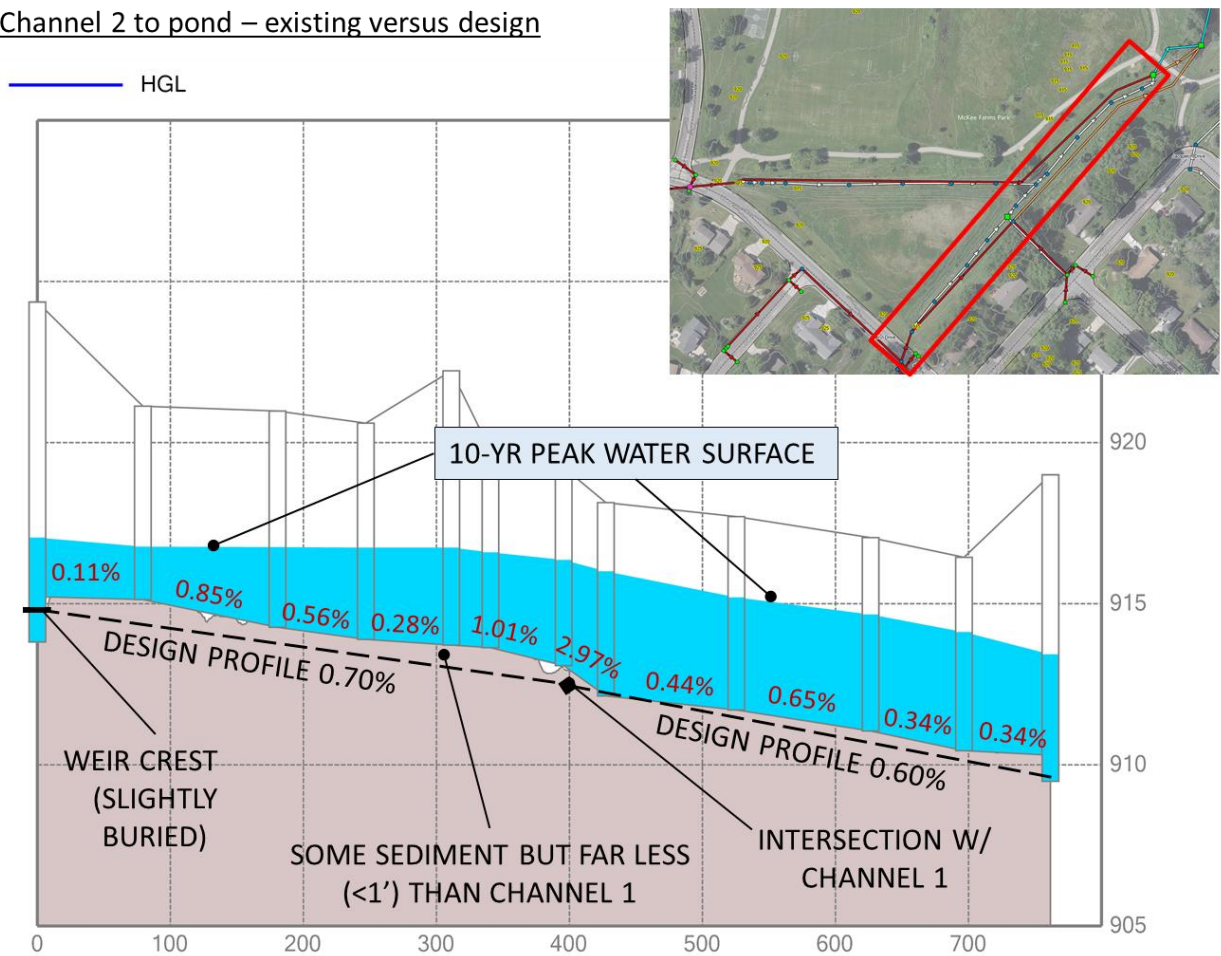
**Figure 7. Existing Channel 2 swale profile compared to design.**

4. "Channel 2" (eastern and combined swale). "Channel No. 2," now referred to as Cheryl Greenway, starts with an almost identical configuration as Channel 1: a shallow stilling basin, an underdrain that outlets to the north near the southern pond, and an overflow weir which carries higher flows into the upper end of Channel 2 and down the swale to the pond culverts. This swale was designed with higher slopes than Channel 1, ranging from 0.6% to 0.7%, but the upper portion is much narrower than Channel 1 with a designed bottom width of only 5 ft (compared to 14 ft for Channel 1). Channel 2 does not have any distinct mounds of sediment and has generally only filled in by 0.75 ft or less, as shown on **Figure 7**. The vegetation cover along the bottom of the swale is generally less dense than Channel 1.

<p>4. "Channel 2" (eastern and combined swale).</p>	<p>N/A for pipes 100-yr flow within banks of designed drainage way: <b>NO</b></p>	<ul style="list-style-type: none"> <li>• Sediment accumulation is lower here than Channel 1, but the portion upstream of the junction with Channel 1 still shows some accumulation compared to design and would benefit from dredging</li> <li>• There appears to be minimal to no accumulation of sediments in Channel 2 between the Channel 1 junction and McKee Farms Park southern pond, but there are considerable sediment deposits on both the upstream and downstream ends of the six culverts leading to the pond</li> <li>• The comments for the Channel 1 stilling basin also apply here – adding a pool and/or lengthening the basin would allow for better sediment trapping and removal</li> <li>• There is flow outside of the banks for the 100-yr event; however, the area is surrounded by park land (no structures), and the 100-year flood elevation was noted on the original design, so this area appears to be functioning as designed. This may be beneficial in terms of overall stormwater management.</li> </ul>

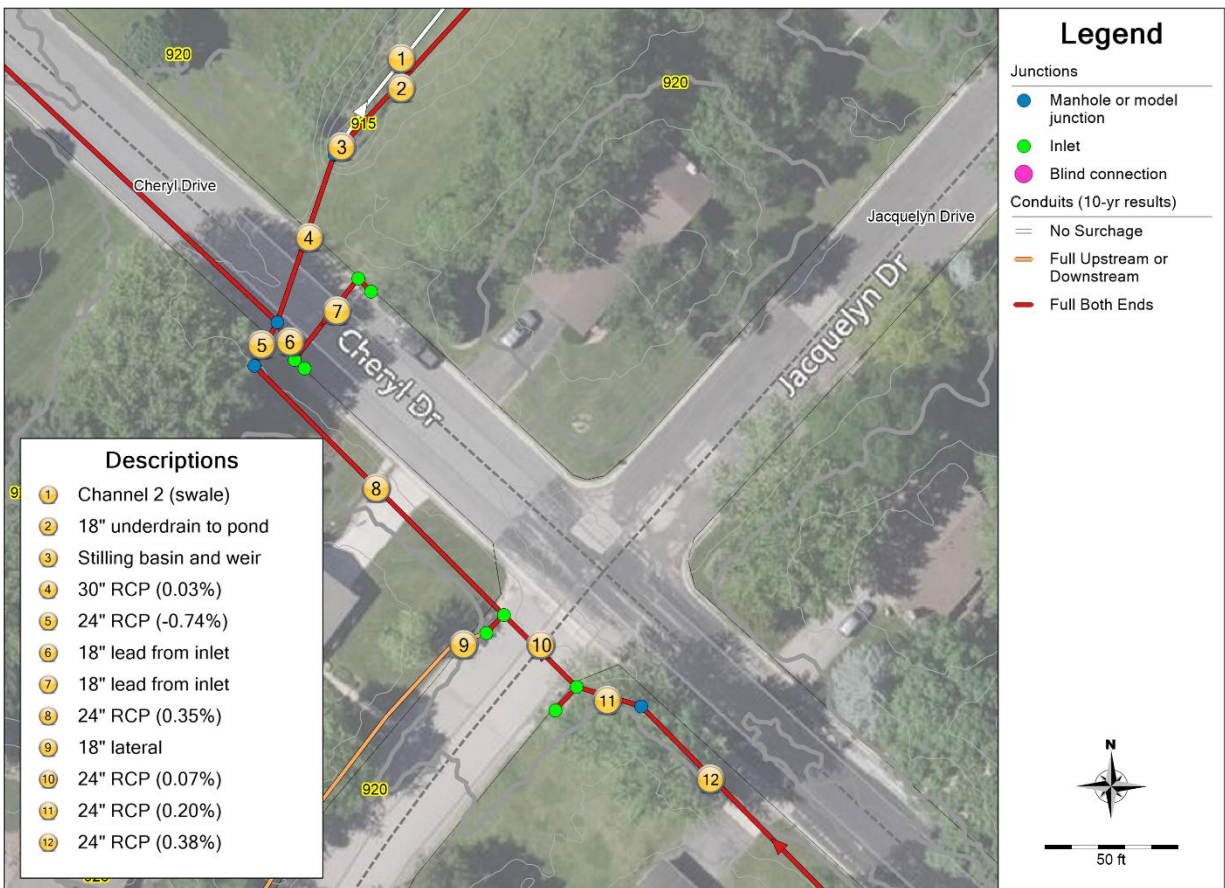
**Figure 8. Storm sewer and start of Channel 2 near Cheryl-Jacquelyn intersection.**

5. Cheryl-Jacquelyn intersection. The area west of the Cheryl Drive – Jacquelyn Drive intersection near the Channel 1 stilling basin, as well as the intersection itself, was reported to have street flooding problems (as seen in the photo on the cover of this report). This location is shown in greater detail in **Figure 8**. There are several curb inlets at these locations, which drain to the Channel 2 stilling basin via 24" and 30" circular pipes. These pipes are generally very low slope (<0.5%), including one short length of adverse (negative) slope 24" pipe that connects the 24" pipe in the terrace to the 30" pipe at the street manhole.

<p>5. Cheryl-Jacquelyn intersection.</p>	<p>Pipe surcharge: &lt; 2-yr</p>	<ul style="list-style-type: none"> <li>• The storm sewer here does not have capacity to handle even the 2-yr event</li> </ul>
