Prepared by: EOR for the City of Fitchburg  
EOR Project #01052-0009

Final Report – submitted November 2021.

## Cheryl Drive Flooding Analysis

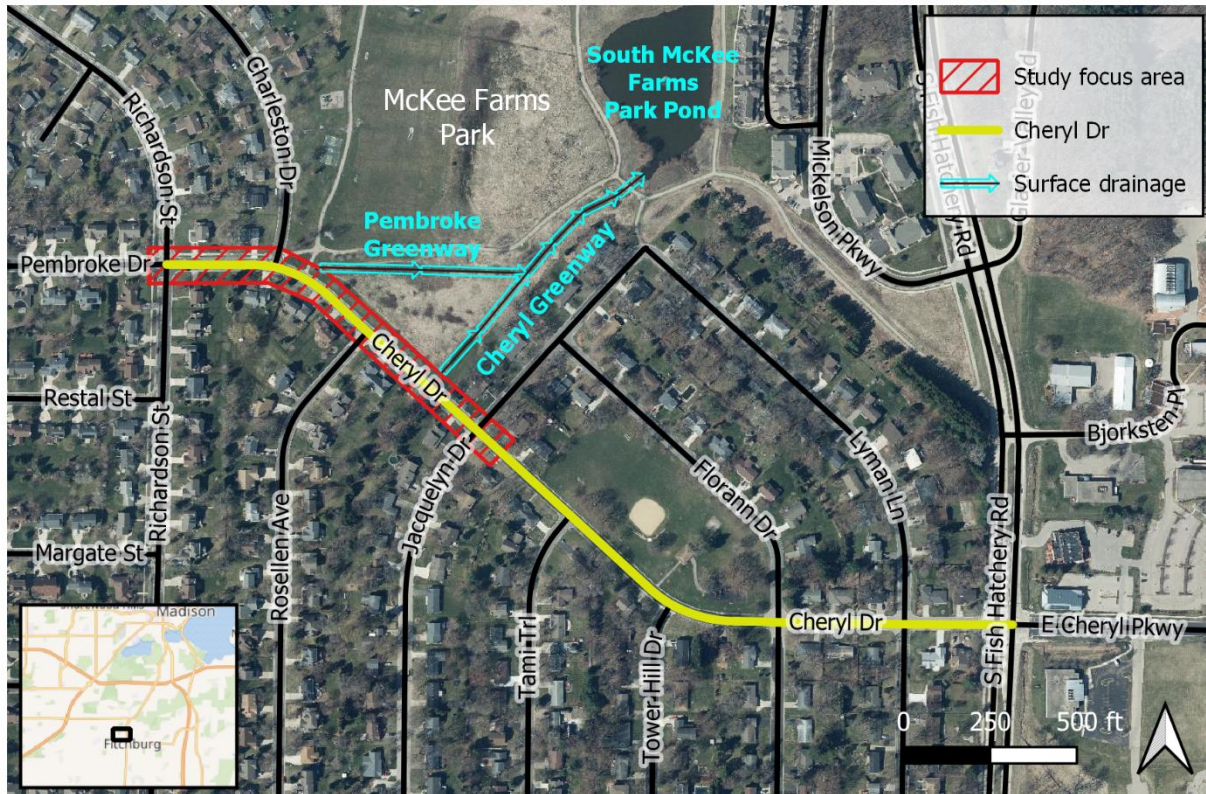
**Figure 1. Project area overview.**

Cheryl Drive (**Figure 1**) is an 8-block long residential street in the Tower Hill neighborhood of the City of Fitchburg (City). Street flooding along the western portions of Cheryl Drive from Richardson Street to Jacquelyn Drive is a known issue which has worsened over the last 20 years. Based on resident accounts, the Charleston Drive – Cheryl Drive intersection has typically experienced standing water in the roadway several times per year, which has backed up onto residents' lawns and driveways during heavier rains. The Jacquelyn Drive – Cheryl Drive intersection also experiences street flooding during relatively common rainfall events.

The section of Cheryl Drive between Charleston Drive and Jacquelyn Drive is a topographic low area that receives runoff from three directions (west, south, and east) including relatively steep areas to the south. Once runoff from the drainage area reaches this portion of Cheryl Drive, it drains through the storm sewer network into two surface drainage channels (swales) in McKee Farms Park that carry water northeast to two connected stormwater ponds in the park (see **Figure 1**). These swales, particularly the western one that starts near the Charleston Drive intersection, have partially filled with sediment since construction. This sediment has covered the concrete weirs at the start of each swale, which limits outflow from the storm sewer into the swales during runoff events.

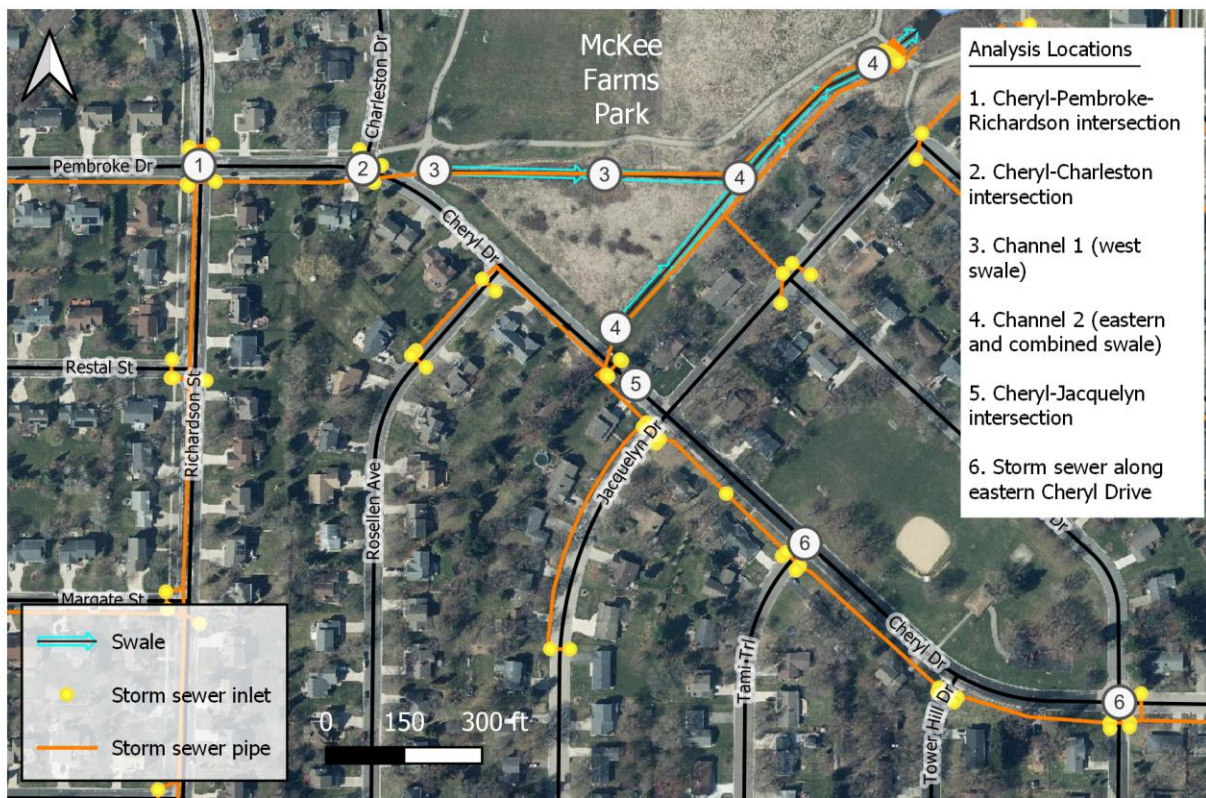
**Figure 4. Focused analysis locations.**

The existing conditions model was assessed, primarily with the 10-yr design storm, to determine how the storm sewer and downstream surface drainage was functioning. The diagnostics focused on six model areas which are shown on **Figure 4** and described below.

1. Cheryl-Pembroke-Richardson intersection. This location, where Richardson Street intersects with Pembroke Drive to the west and Cheryl Drive to the east, is along a section of roadway that flows downhill at a steeper slope (~2%) than other sections of Cheryl Drive. There are six inlets at this intersection. Stormwater that is not captured by these inlets flows downhill along Cheryl Drive towards the Cheryl-Charleston intersection, potentially exacerbating the known flooding problems there.
2. Cheryl-Charleston intersection. This location is shown in greater detail in **Figure 5**. Flooding problems at this specific intersection prompted this project. The storm sewer here transitions from a 42" diameter circular pipe at 1.5% slope to the west to a 34" x 53" elliptical pipe at a much lower

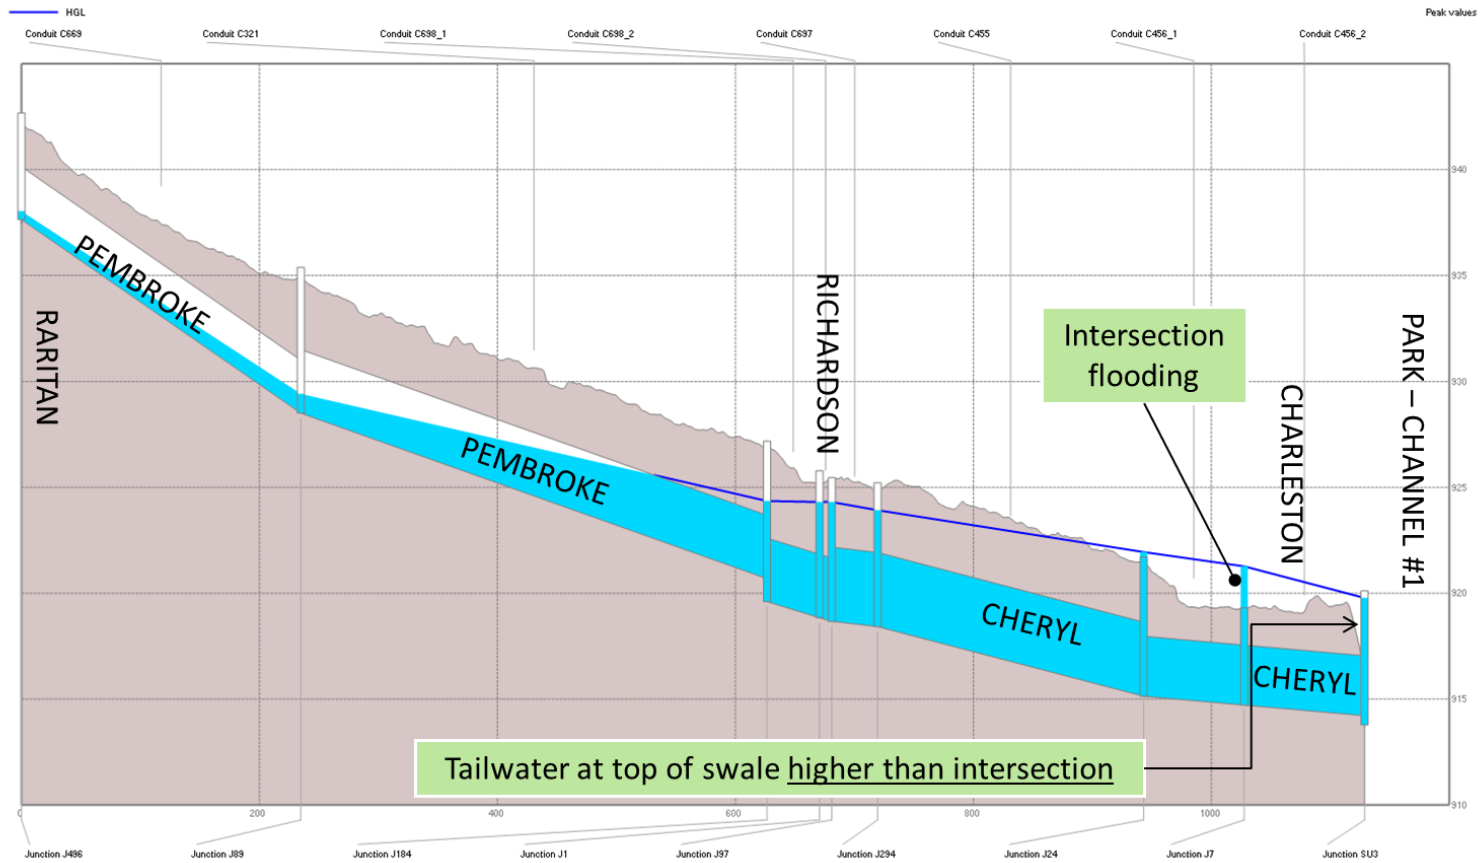
Figure A2 – 10-yr peak hydraulic grade line from Raritan Street to McKee Farms Park along Cheryl Drive.

# 10-YR PROFILE FROM RARITAN TO MCKEE FARMS PARK ALONG CHERYL - PEMBROKE

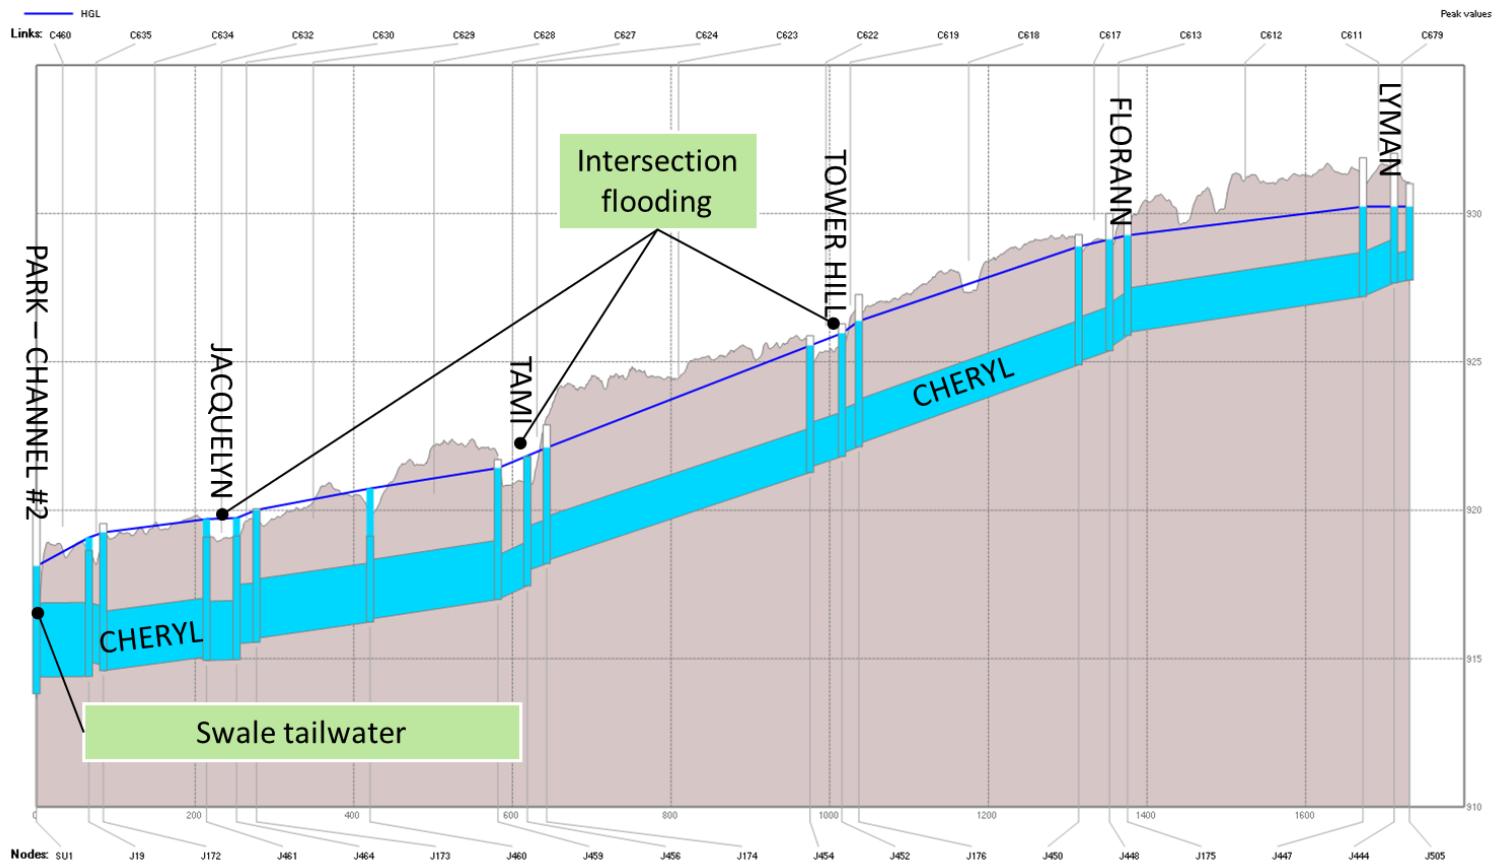
Figure A3 – 10-yr peak hydraulic grade line from Lyman Lane to McKee Farms Park along Cheryl Drive.

# 10-YR PROFILE FROM LYMAN TO MCKEE FARMS PARK ALONG CHERYL DR

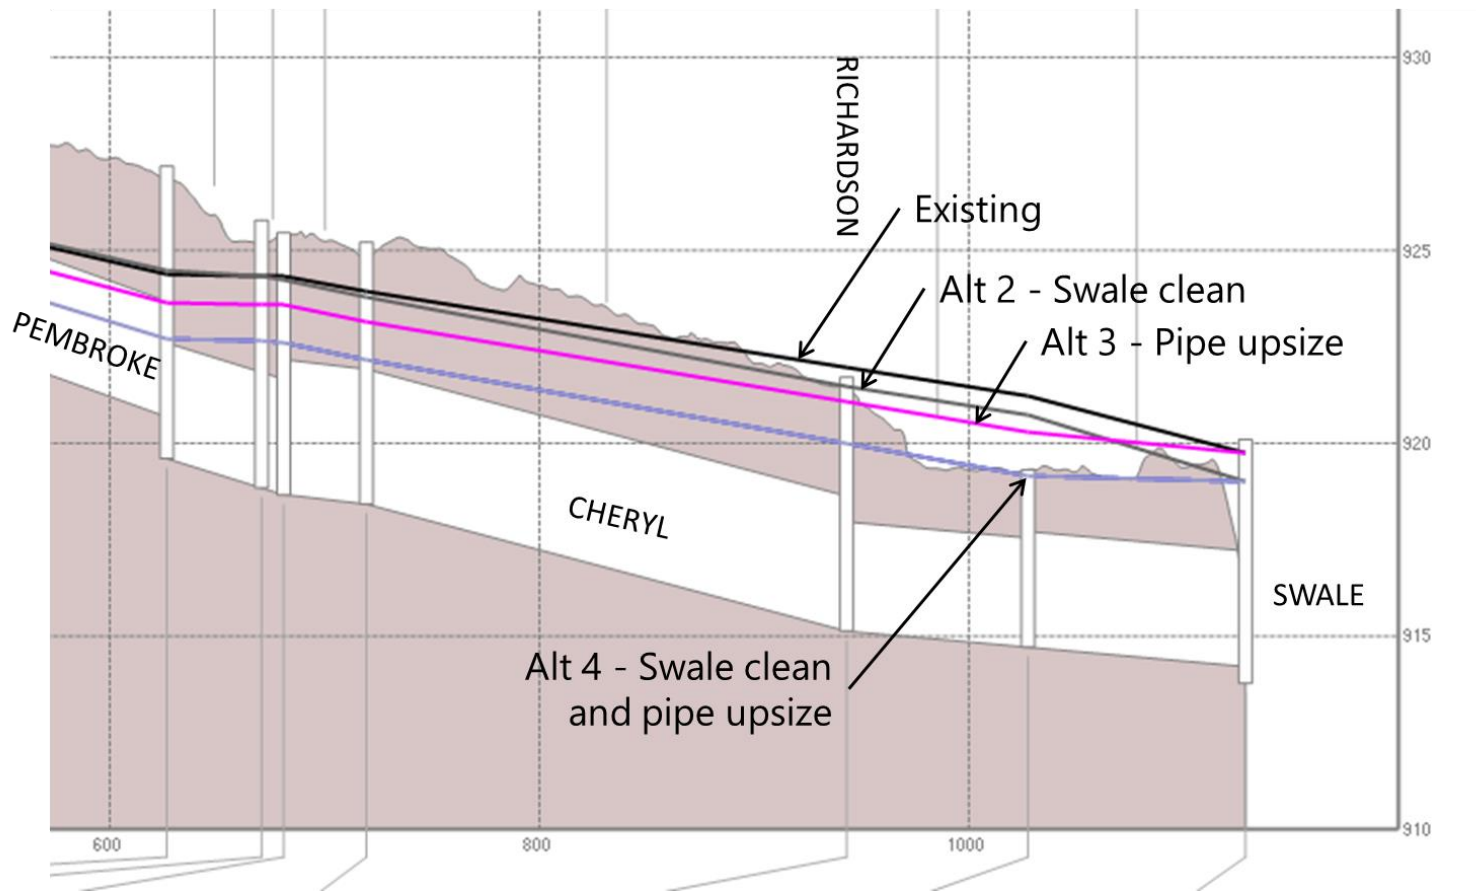
Figure A4 – 10-yr peak hydraulic grade line for different alternatives from Pembroke to McKee Farms Park along Cheryl Drive.

# ALTERNATIVES COMPARISON – WESTERN AREA

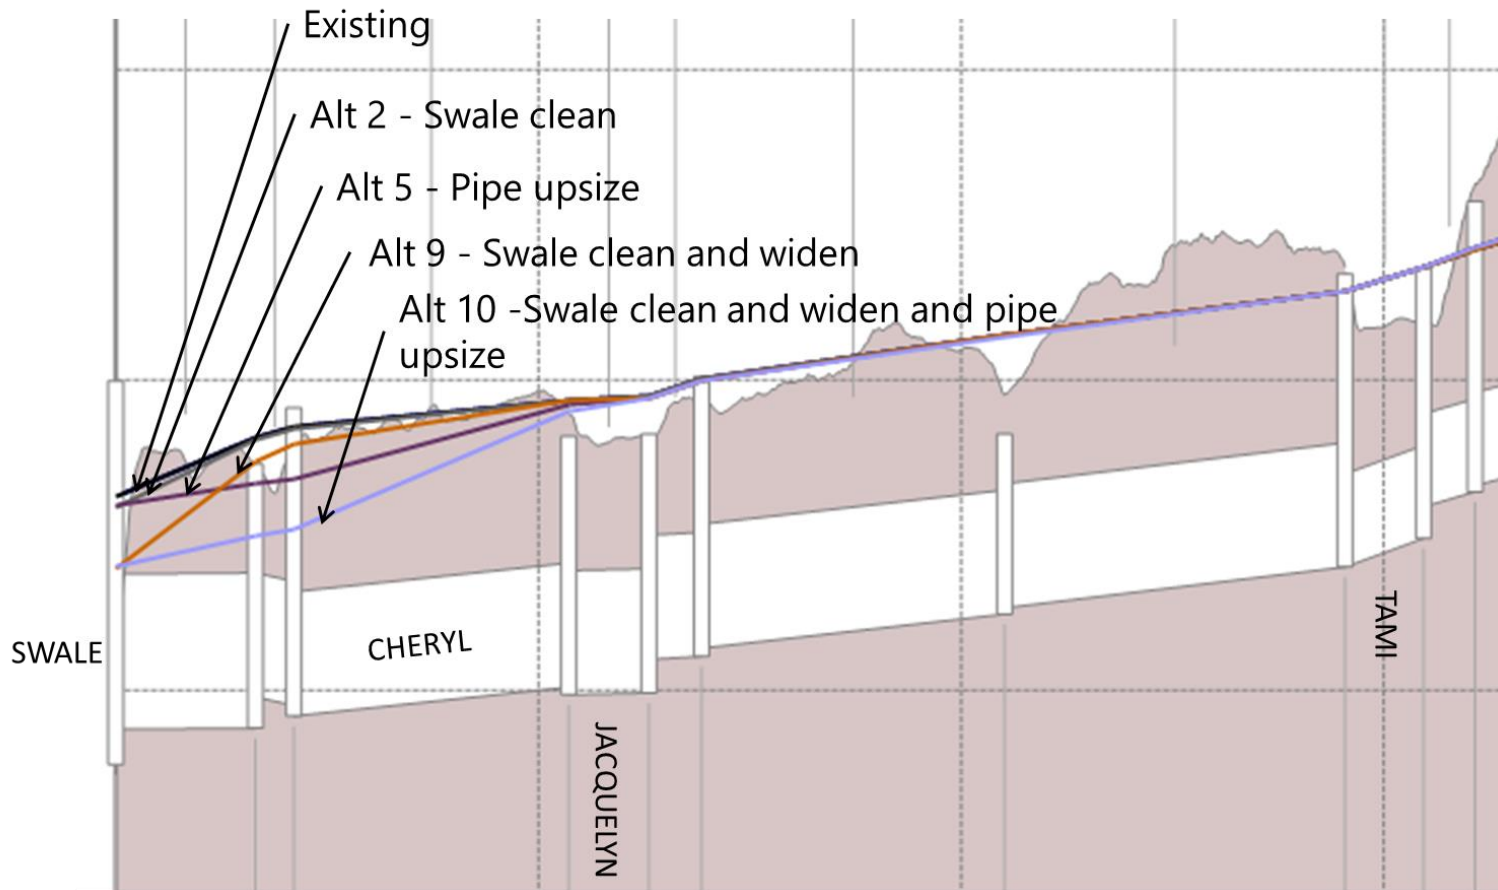
Figure A5 – 10-yr peak hydraulic grade line for different alternatives from Tami Trail to McKee Farms Park along Cheryl Drive.

# ALTERNATIVES COMPARISON – EASTERN AREA <sup>50</sup>
